Research on Construction Technology of Tunnel Face Slump in Soft Rock Tunnel of China-Laos Railway

WANG Kai-jun

China Railway 15th Bureau Group 3rd Engineering Co., Ltd., Chengdu 611731, China

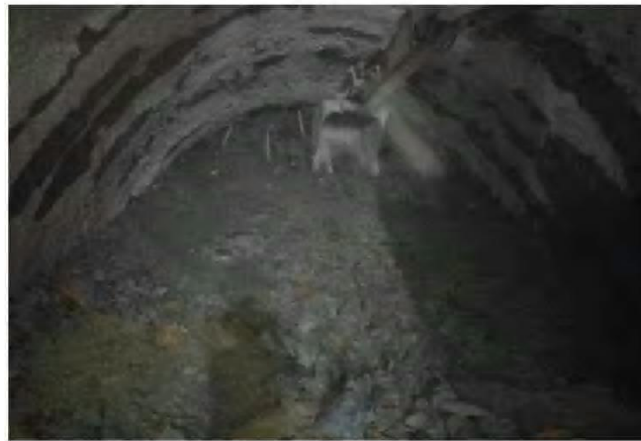
face slag completion, in the slag raking process palm face right shoulder suddenly appeared to fall block phenomenon, after the palm face right arch began to slip and collapse, until the entire palm face is almost completely closed (see Figure 2 shows), slip and collapse of the composition of the body is mainly for the charcoal mudstone, and seepage of water into the line. As a result of timely evacuation, the collapse did not cause casualties and no equipment damage. The cross-section of the tunnel collapse and the site pictures are shown in Figure 1 and Figure 2.

Figure 2 Barrow II tunnel slip and fall site figure.

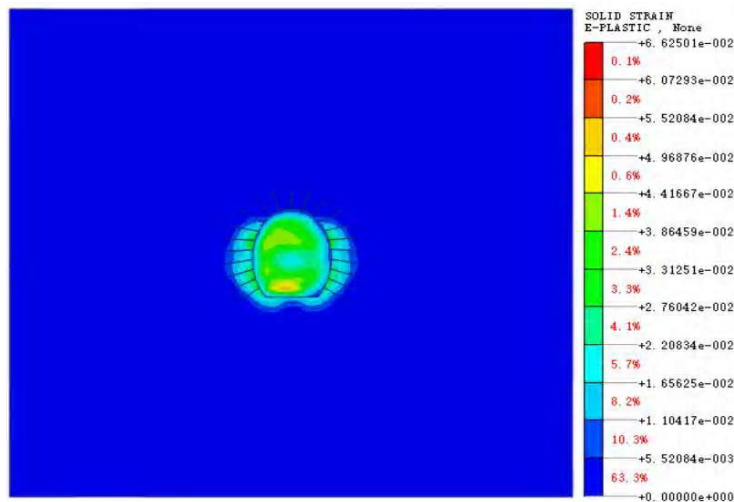
The distribution of the plastic zone of the tunnel surrounding rock is shown in Figure 5. As can be seen from Figure 5, the plastic zone of surrounding rock is mainly concentrated at the upper and lower steps of the palm face, the arch waist and the super-elevation arch position. The maximum value of plastic strain at the position of arch waist and back arch of the tunnel is $6.63 \cdot 10^{-2}$, and the distribution of the plastic zone can be seen from the distribution map.

Figure 5 Analysis of the plastic zone of the surrounding rock.

(3) Through the finite element software, the simulation of the tunnel construction stage, there are simulation results can be seen, the tunnel arch and arch waist position at the peripheral rock deformation value is larger, and the peripheral rock plastic zone is mainly concentrated in the distribution of the arch waist position, indicating that the peripheral rock stability is poor, in the excavation process occurs sliding collapse risk is greater.

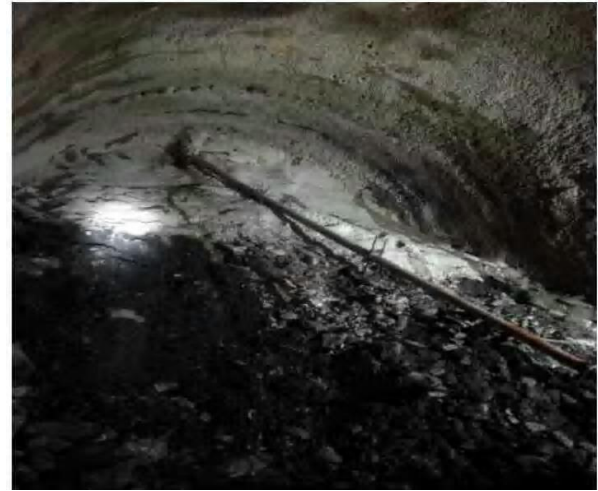
Figure 7 Spray anchor diagram.

(2) Rapidly on the surface of the pile of body spray anchor closed, standard C25 spray anchor thickness of 10cm, (see Figure 7) to ensure that the pile of body stabilization no longer collapsed and slipped, while ensuring the safety of the lower personnel and machinery and equipment.
