Construction Technology of Tunnel Consolidation Excavation in Water-rich Soft and Broken Rock Formations

Abstract: Combined with the example of the Junchang Tunnel of Censhui Expressway in the middle and Guangxi section of Baomao Expressway, this paper briefly introduces the four major mud and water inrush disasters that occurred, and expounds the causes of the disasters. Consolidation excavation of the tunnel has made a summary of construction technology.

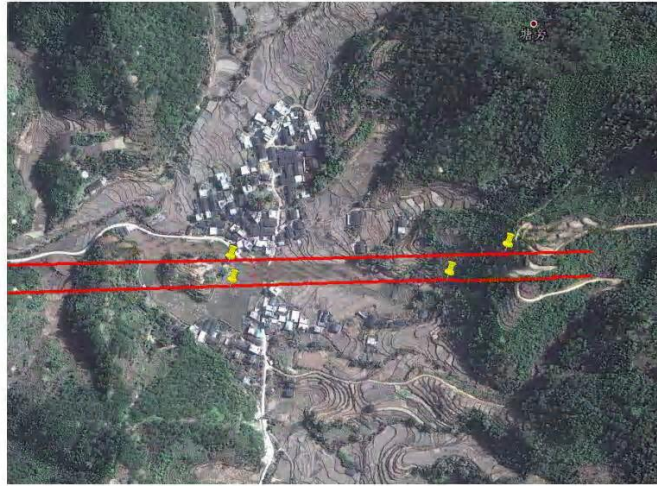
Figure 1 Schematic diagram of unconnected section.

The Censhui Expressway is an extremely important section of the north-south trunk line of China's expressway network, Baomao Expressway, with a total length of 30.7km. It is one of the highway sections with the highest bridge tunnel ratio (41.54%) in Guangxi. The Junchang Tunnel is a separated small clear distance two-way four lane extra long tunnel. The starting and ending pile numbers of the left line are DK6+450 Yao DK10+730, with a length of 4280m. The starting and ending pile numbers of the right line are CK6+475 Yao CK10+770, with a length of 4295m. The distance between the center lines of the two lanes is 29m, with a clear distance of 15m and a clearance (hole width height) of 1-10.75 meters. The remaining unfinished section is located below Shanxin Village, with a burial depth of approximately 85-105m. Belonging to the micro basin terrain, it has extremely strong water collection capacity. The surrounding rock is fully strongly weathered granite, with weak and fractured rock layers rich in water and well-developed joints and fissures. The water transmission in the area is unobstructed. (Figures 1 and 2)

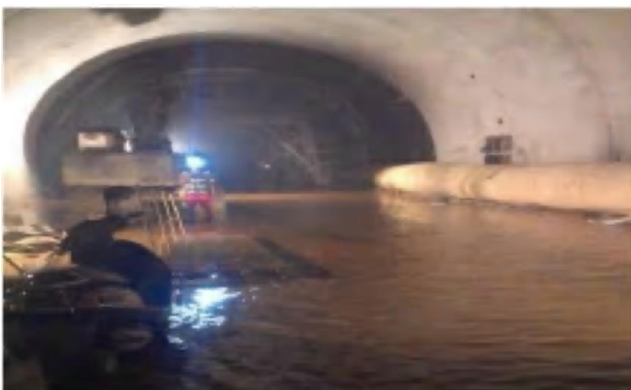
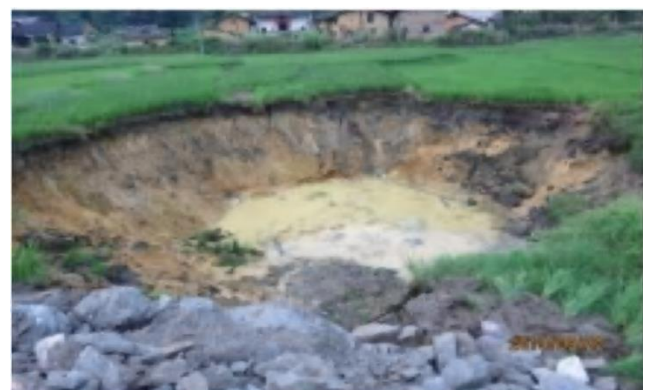
Figure 3 Surface collapse in muddy and watery areas.

a maximum water inflow of $1195\text{m}^3/\text{h}$. Two days later, the water inflow remained at $695\text{m}^3/\text{h}$. After 1 day of water inrush in the tunnel, there was a collapse on the surface 790m away from the tunnel face, and the well pond had dried up. After 11 days of water inrush, there were also large collapse pits on the surface above the face, and local collapse and deformation of the initial support in the tunnel were severe, with more obvious deformation of the left tunnel initial support and a cumulative water inrush of $25 \times 104\text{m}^3$, with approximately 2500m^3 of mud and sand accumulation. (Figure 3)

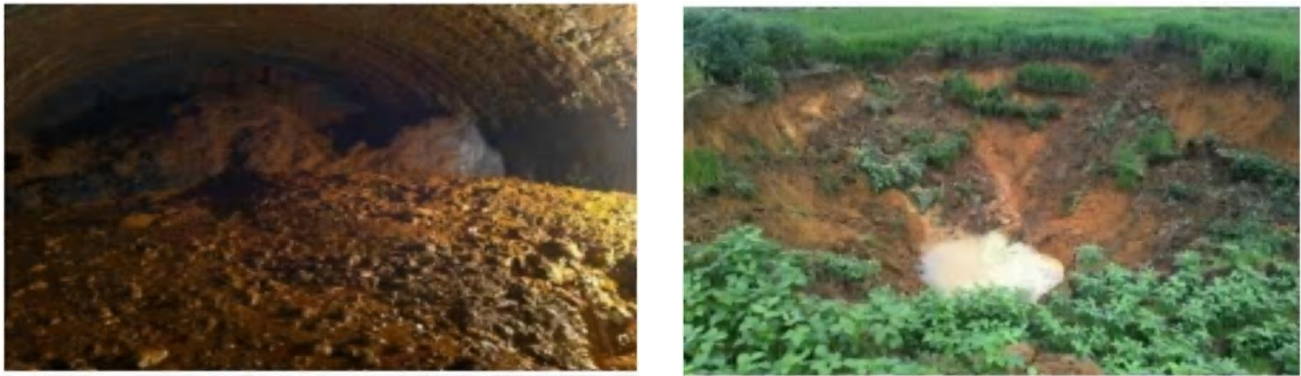
Figure 4 Surface collapse of Tu Ni Yao.

meters. The palm face is buried at a depth of 100m, and a collapse pit with a diameter of 13m and a depth of 7m appears in front of the palm face surface. (Figure 4)

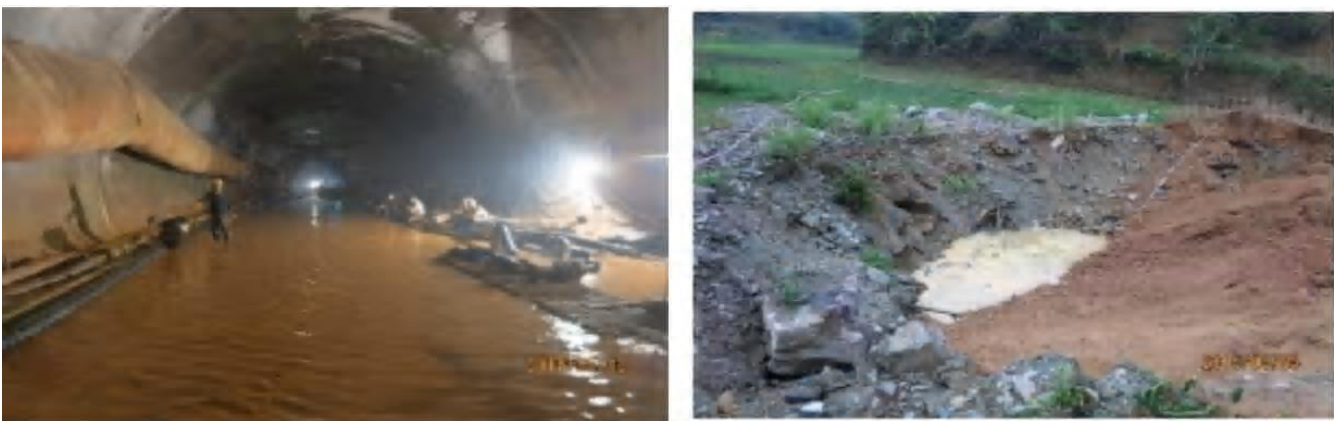
Figure 5 Surface collapse situation of sudden mud and water gushing Yao.

On May 1, 2015, the original water and mud inrush section was treated on the upper steps of the palm face and advanced to CK7+834.5 mileage. During the initial support construction, there was a surge of water at the right arch foot of the upper step, with a diameter of about 15cm and a water inflow of about 38m³/h. After 2 hours of successful sealing, the water inflow increased and broke through the closed sand bag and palm face, increasing to 605m³/h. After 1 day of water inrush, several rivers near the surface of Shanxin Village Committee collapsed due to water interruption. After 4 days of water inrush, deeper sinkholes reappeared at the original surface collapse caused by the geological disaster of 9.11 water inrush and mud inrush. It was not until May 9th that the right tunnel of the tunnel face was effectively sealed, and during the process, the cumulative water inflow reached $10 \times 10^4 \text{m}^3$, with mud and sand accumulation of about 1000m³. (Figure 5)

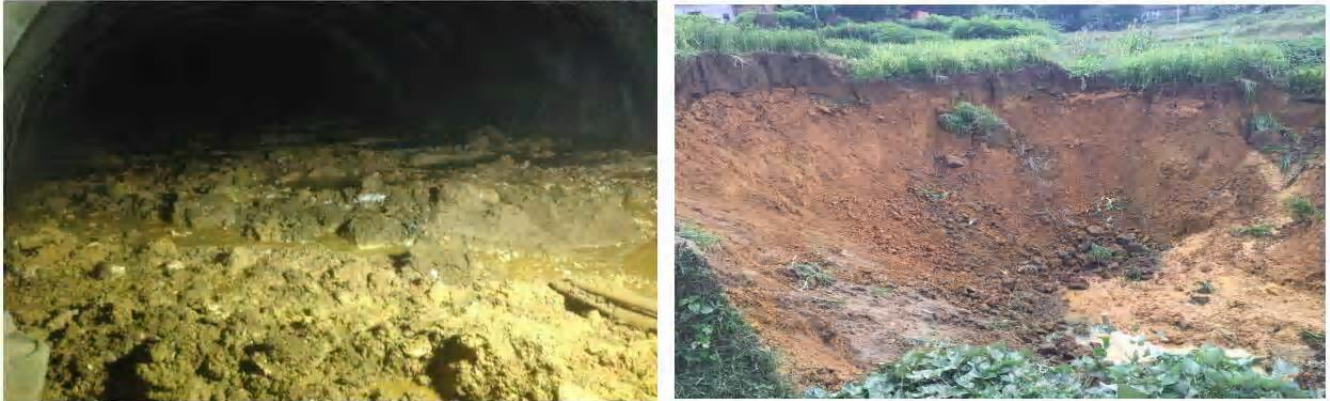
Figure 6 Surface collapse of Tu Ni Yao.

On October 23, 2015, when the upper step of the left exit of the Junchang Tunnel was used to treat the original water and mud inrush section and excavated to DK7+938.5, there was another water and mud inrush on the face, which lasted for 5 hours. The maximum water inflow reached 650m³/h, and the mud inrush was about 2500 cubic meters. A funnel-shaped collapse pit with a diameter of 8m and a depth of 10m appeared on the surface in front of the palm. (Figure 6)

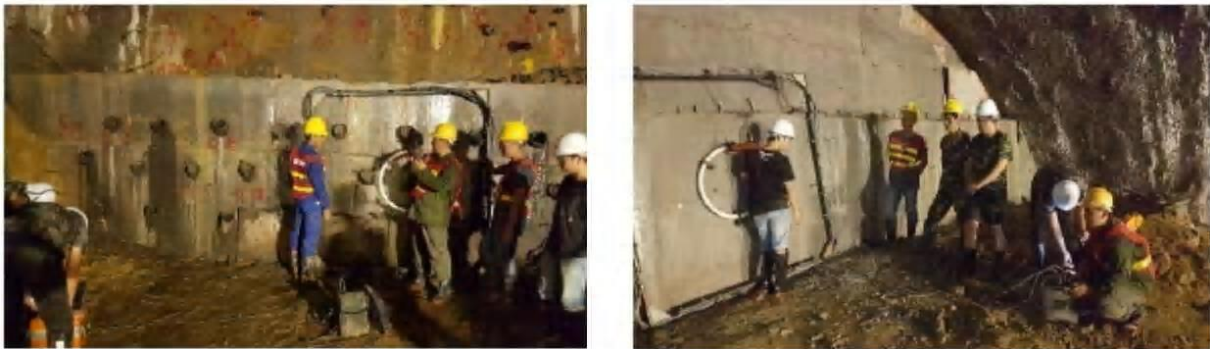
Figure 7 Transient electromagnetic detection of left and right holes.

The engineering geological and hydrogeological conditions of the unconnected section of the Junchang Tunnel are extremely complex. In order to further explore the structural fracture zone, weak interlayers, and underground water burial and distribution in front of the tunnel face in the unconnected section, and provide technical references for underground water sealing, surrounding rock reinforcement, and tunnel excavation, advanced geological predictions were made for the left and right tunnels in the unconnected section using methods such as transient electromagnetic method, land sonar method, and differential electrical exploration method, During the curtain grouting process, horizontal advanced drilling holes were also used for verification. (Figure 7)

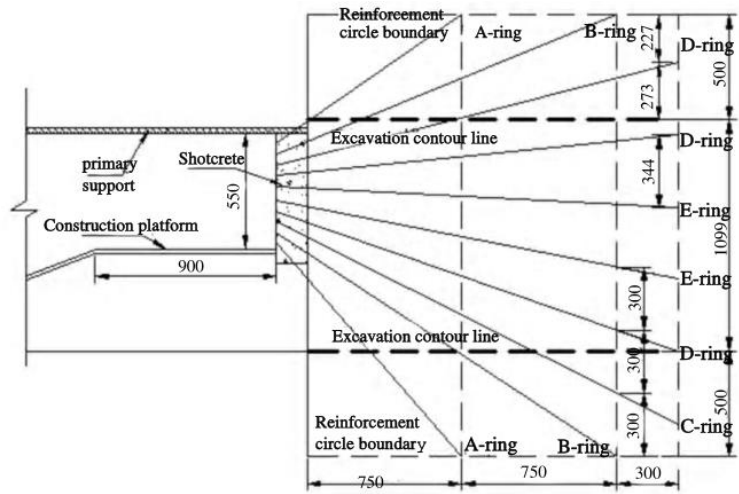
Figure 9 Schematic diagram of segmented cross-section of curtain grouting.

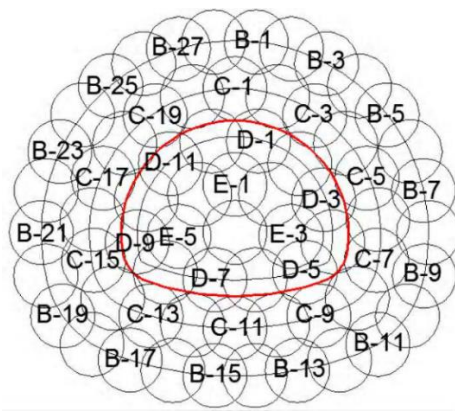
Figure 10 Schematic diagram of slurry diffusion and intersection at the final hole position of curtain grouting.

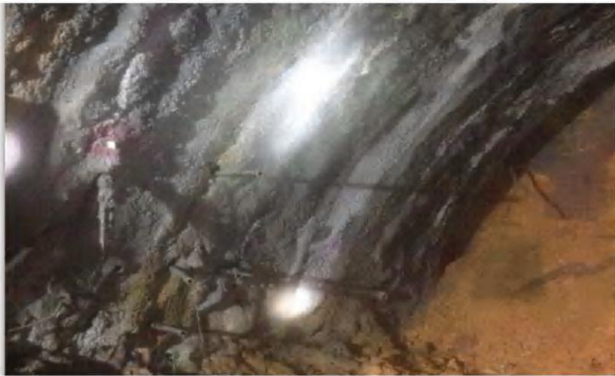
Figure 11 Radial supplementary grouting construction.

(1) The initial support seepage is achieved by using a small conduit radial supplementary grouting method to seal the water source channel and reinforce the surrounding rock that has already been initially supported.

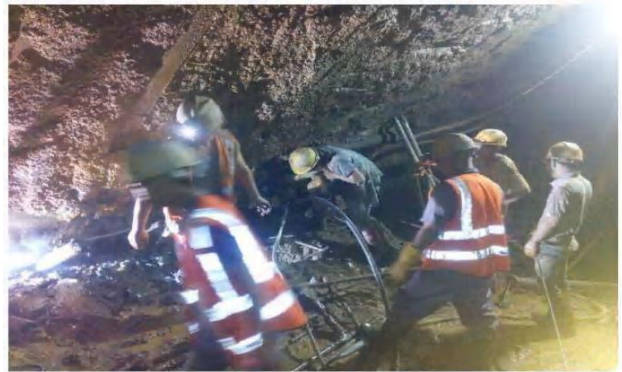
Figure 12 Construction of large lock foot drilling and grouting.

(2) The initial support sinks and cracks, and $\phi 108$ steel pipe large locking feet are used to lock the arch, and grouting is used to reinforce the rock layer, with each 6m and a spacing of 0.5m.

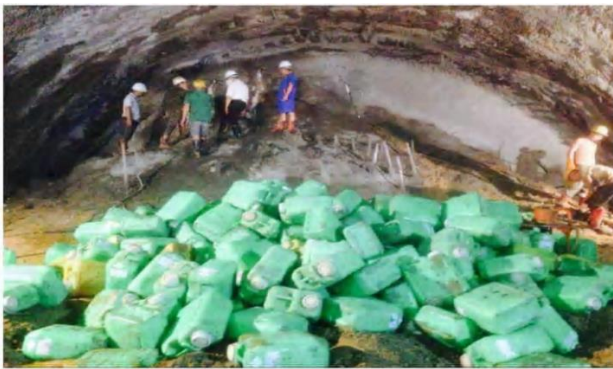
Figure 13 Weideke chemical slurry supplementary grouting.

(3) During the excavation process, there is a phenomenon of water seepage and collapse in front of the palm. After using steel mesh and sprayed concrete to seal it, it is difficult to excavate, and large machinery is also difficult to enter the borehole for grouting. Therefore, air drills are used for drilling, and other chemical grouting fluids such as Weideke are used. A small ZBQ-5/12 grouting pump is used to quickly supplement the grouting and seal the front of the palm, and then continue excavation, and so on, but cannot exceed the original excavation length.

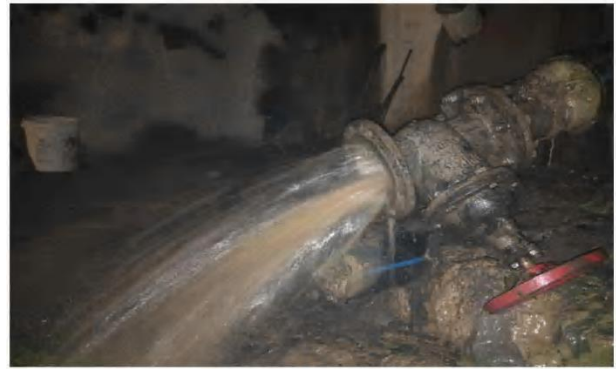
Figure 14 Drilling drainage holes for water diversion and drainage.

(4) The initial support seepage and arch foot water seepage are relatively serious. Therefore, drilling drainage holes on the side of the initial support is adopted to ensure the stability and safety of the rock layer
